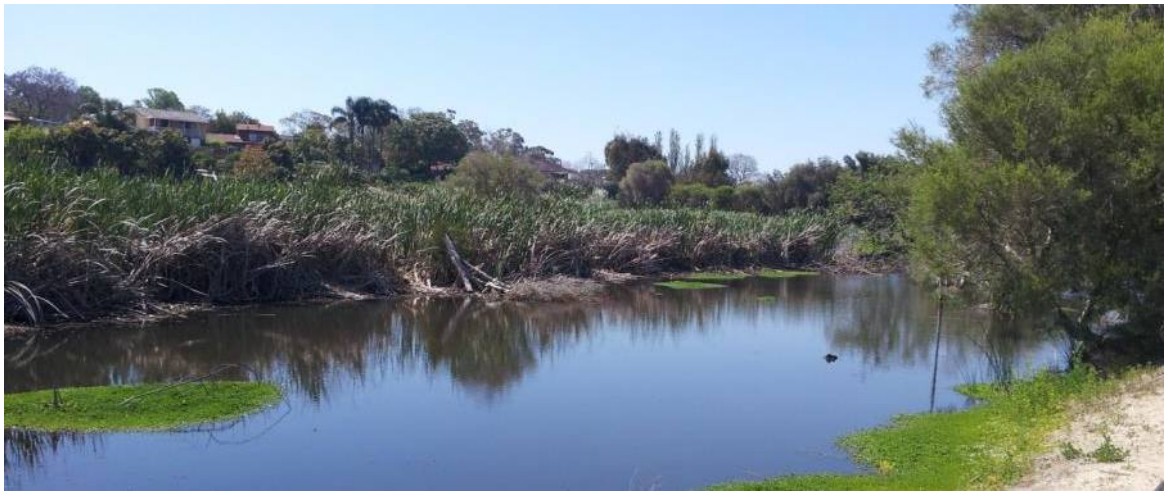
Plate 2 Channel next to Secondary Lake, Baigup Wetland Reserve

The constructed wetlands are fringed by both native and weed species and offer excellent habitat, particularly for waterbirds.

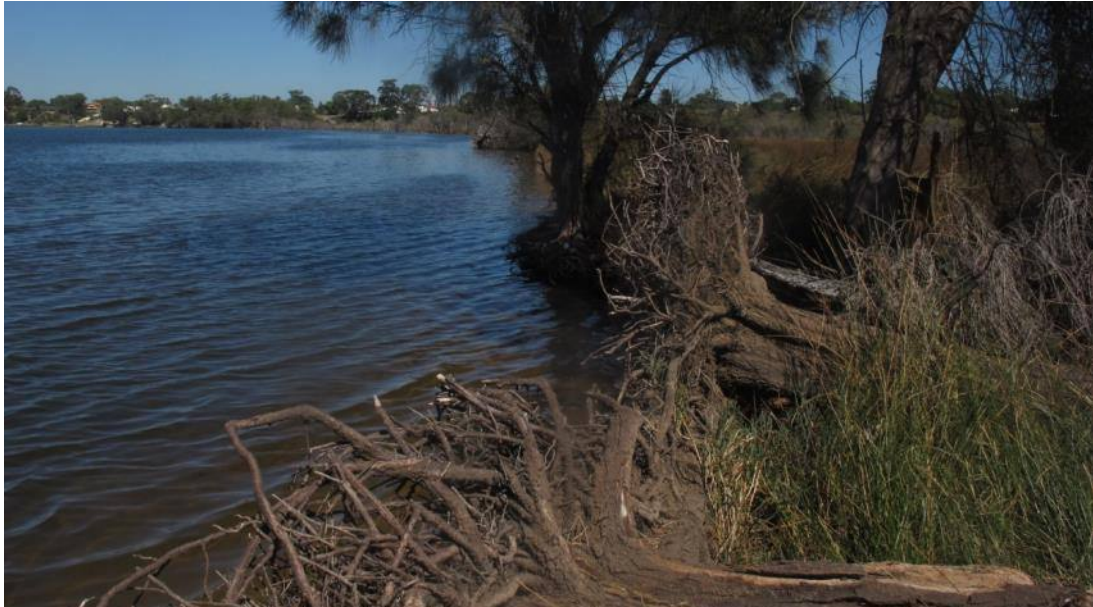
Plate 4 Fallen trees along Baigup Wetland Reserve banks (eastern end of Reserve)

The 2004 management plan (Regeneration Technology 2004) noted that erosion is a major problem along the river foreshore, especially in the eastern end of the Reserve. Wave wash from boats has impacted on the sandy shoreline. The river in this area is relatively shallow and this, combined with the low height of the Garratt Road bridge means the boating traffic travels on the northern side of the river and Baigup foreshore gets substantial wave wash. A Swan River Trust, foreshore assessment of the area that included Baigup Wetland Reserve considered that there was moderate evidence of erosion (Swan River Trust 2008). Bank instability, including fallen trees, was noted during the 2015 field visit (Plate 4) and movement of the foreshore bank is likely to be an ongoing and dynamic process. In recent years, further erosion at the western end has brought high tides up to the path on numerous occasions (P Lee, BWIG, 2015 pers comm. 10 May)

A number of erosion control techniques have been used in the past along the Baigup foreshore including bollard river bank protection at the eastern end of the Reserve. However, there do not appear to be any ongoing control techniques in place. The natural migration of the foreshore over time is an acceptable method of 'managed retreat' (Swan River Trust 2008). However, ongoing monitoring of the infrastructure through engineering assessments is required to ensure that erosion does not start to impact on infrastructure and thus create a safety risk, such as on the boardwalk at the eastern end. COB will work in partnership with the Swan River Trust to assess the erosion along Baigup Reserve and develop a management plan.

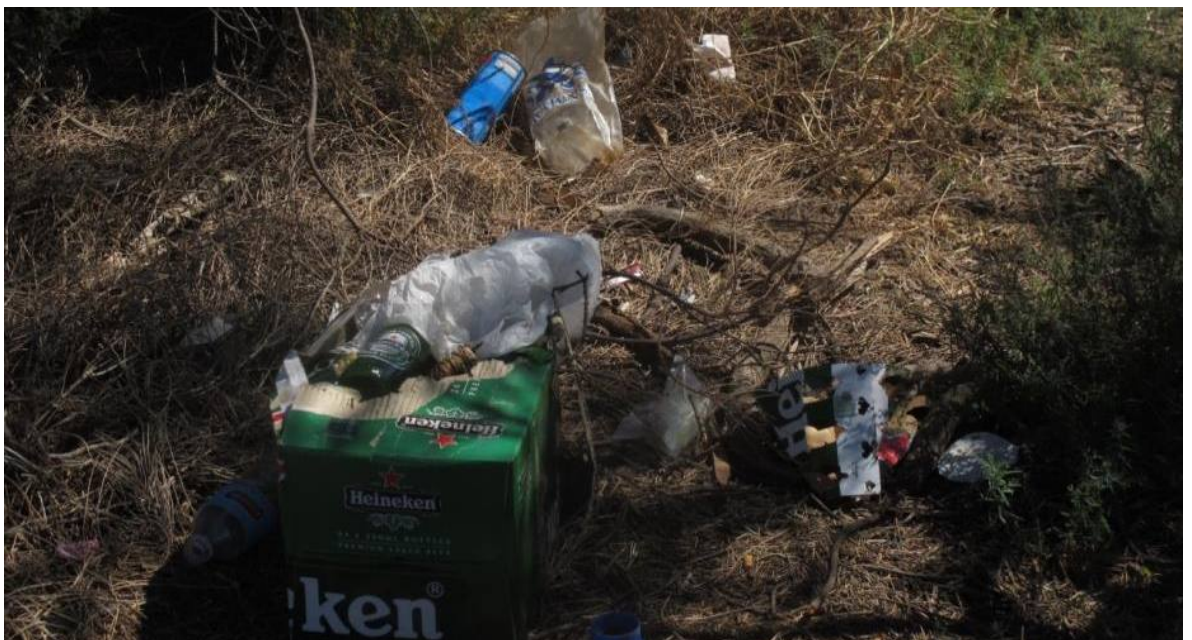
Plate 5 Litter along the foreshore at Baigup Wetland Reserve

Vandalism can include destruction of property and facilities as well as damage to native vegetation, such as tree poisoning and illegal clearing. Dumping of large amounts of rubbish in the Reserve is uncommon as access is generally well regulated; however littering is a low level threat associated with public use of the Reserve. Significant areas of litter were noted during the field visit, and predominantly occurred along the foreshore along the unofficial tracks discussed in Section 4.6 (Plate 5). This litter included plastics, bottles and other packaging materials which, due to the proximity to the river have the potential to enter the river system and be a threat to fauna species.

COB has assessed the Reserve for rubbish bin placement and an additional bin has been placed on the east side of Garratt Road Bridge with a fishing line bin at the river edge. Other strategies to discourage littering in this area of the Reserve should be considered in consultation with the local community and may include measures such as:

- Erection of signs at the Garratt Road entrance of the Reserve outlining the environmental significance of the Reserve and reminding people to remove their rubbish
- Undertake a community clean-up day to ensure rubbish doesn't accumulate.

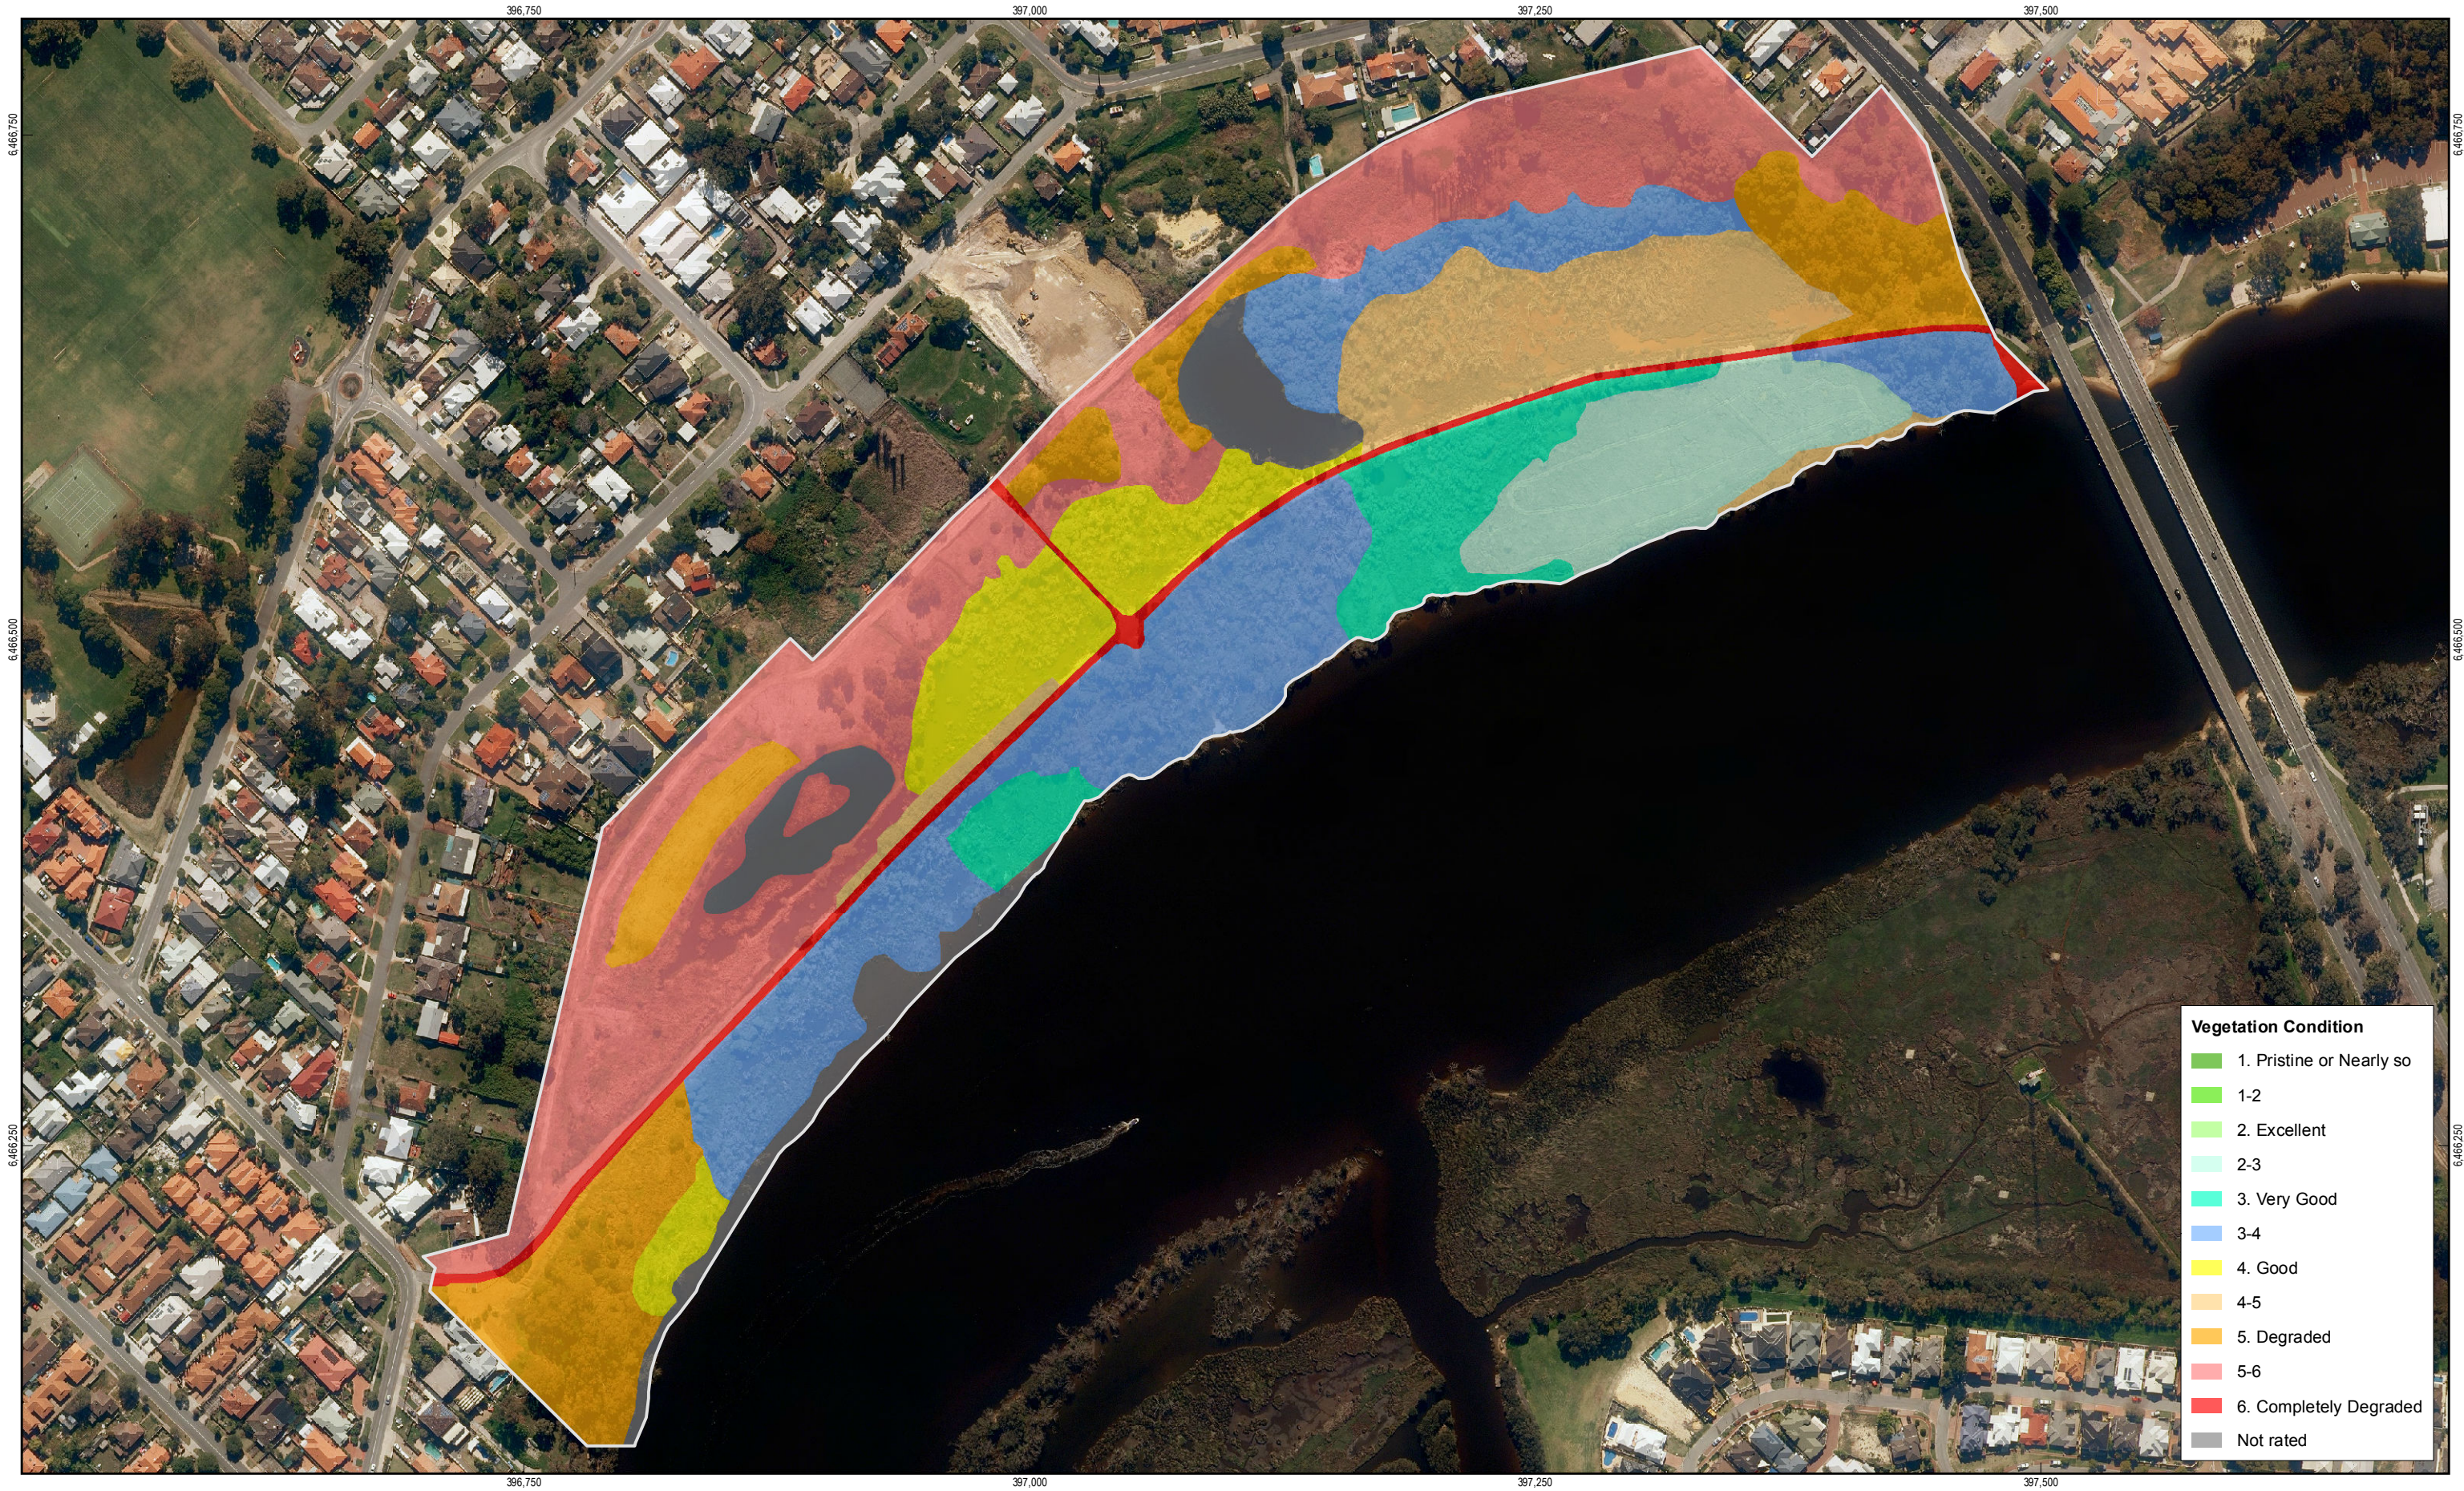
Figure 3

The vegetation condition of the Reserve has been mapped previously (Regeneration Technology 1994, 2004; Randall and Storer 2010) and was re-assessed and mapped during the March 2015 field visit (Figure 3, Appendix A).

In general, the vegetation on the south (river) side of the dual-use path is in better condition than that on the north side. The vegetation condition on the south side of the path has, however, been partly altered by low-level weed invasion, trampling of vegetation, deaths of native vegetation (specifically *Melaleuca raphiophylla*) and traversing by an all-terrain vehicle (ATV) used for mosquito control in 2014/2015. The vegetation at the western end of the Reserve, on the south side of the path is generally in poor condition and is dominated by weedy species, with large areas smothered by *Ipomoea* sp. (Morning Glory) and *Dipogon lignosus* (Dolichos Pea).

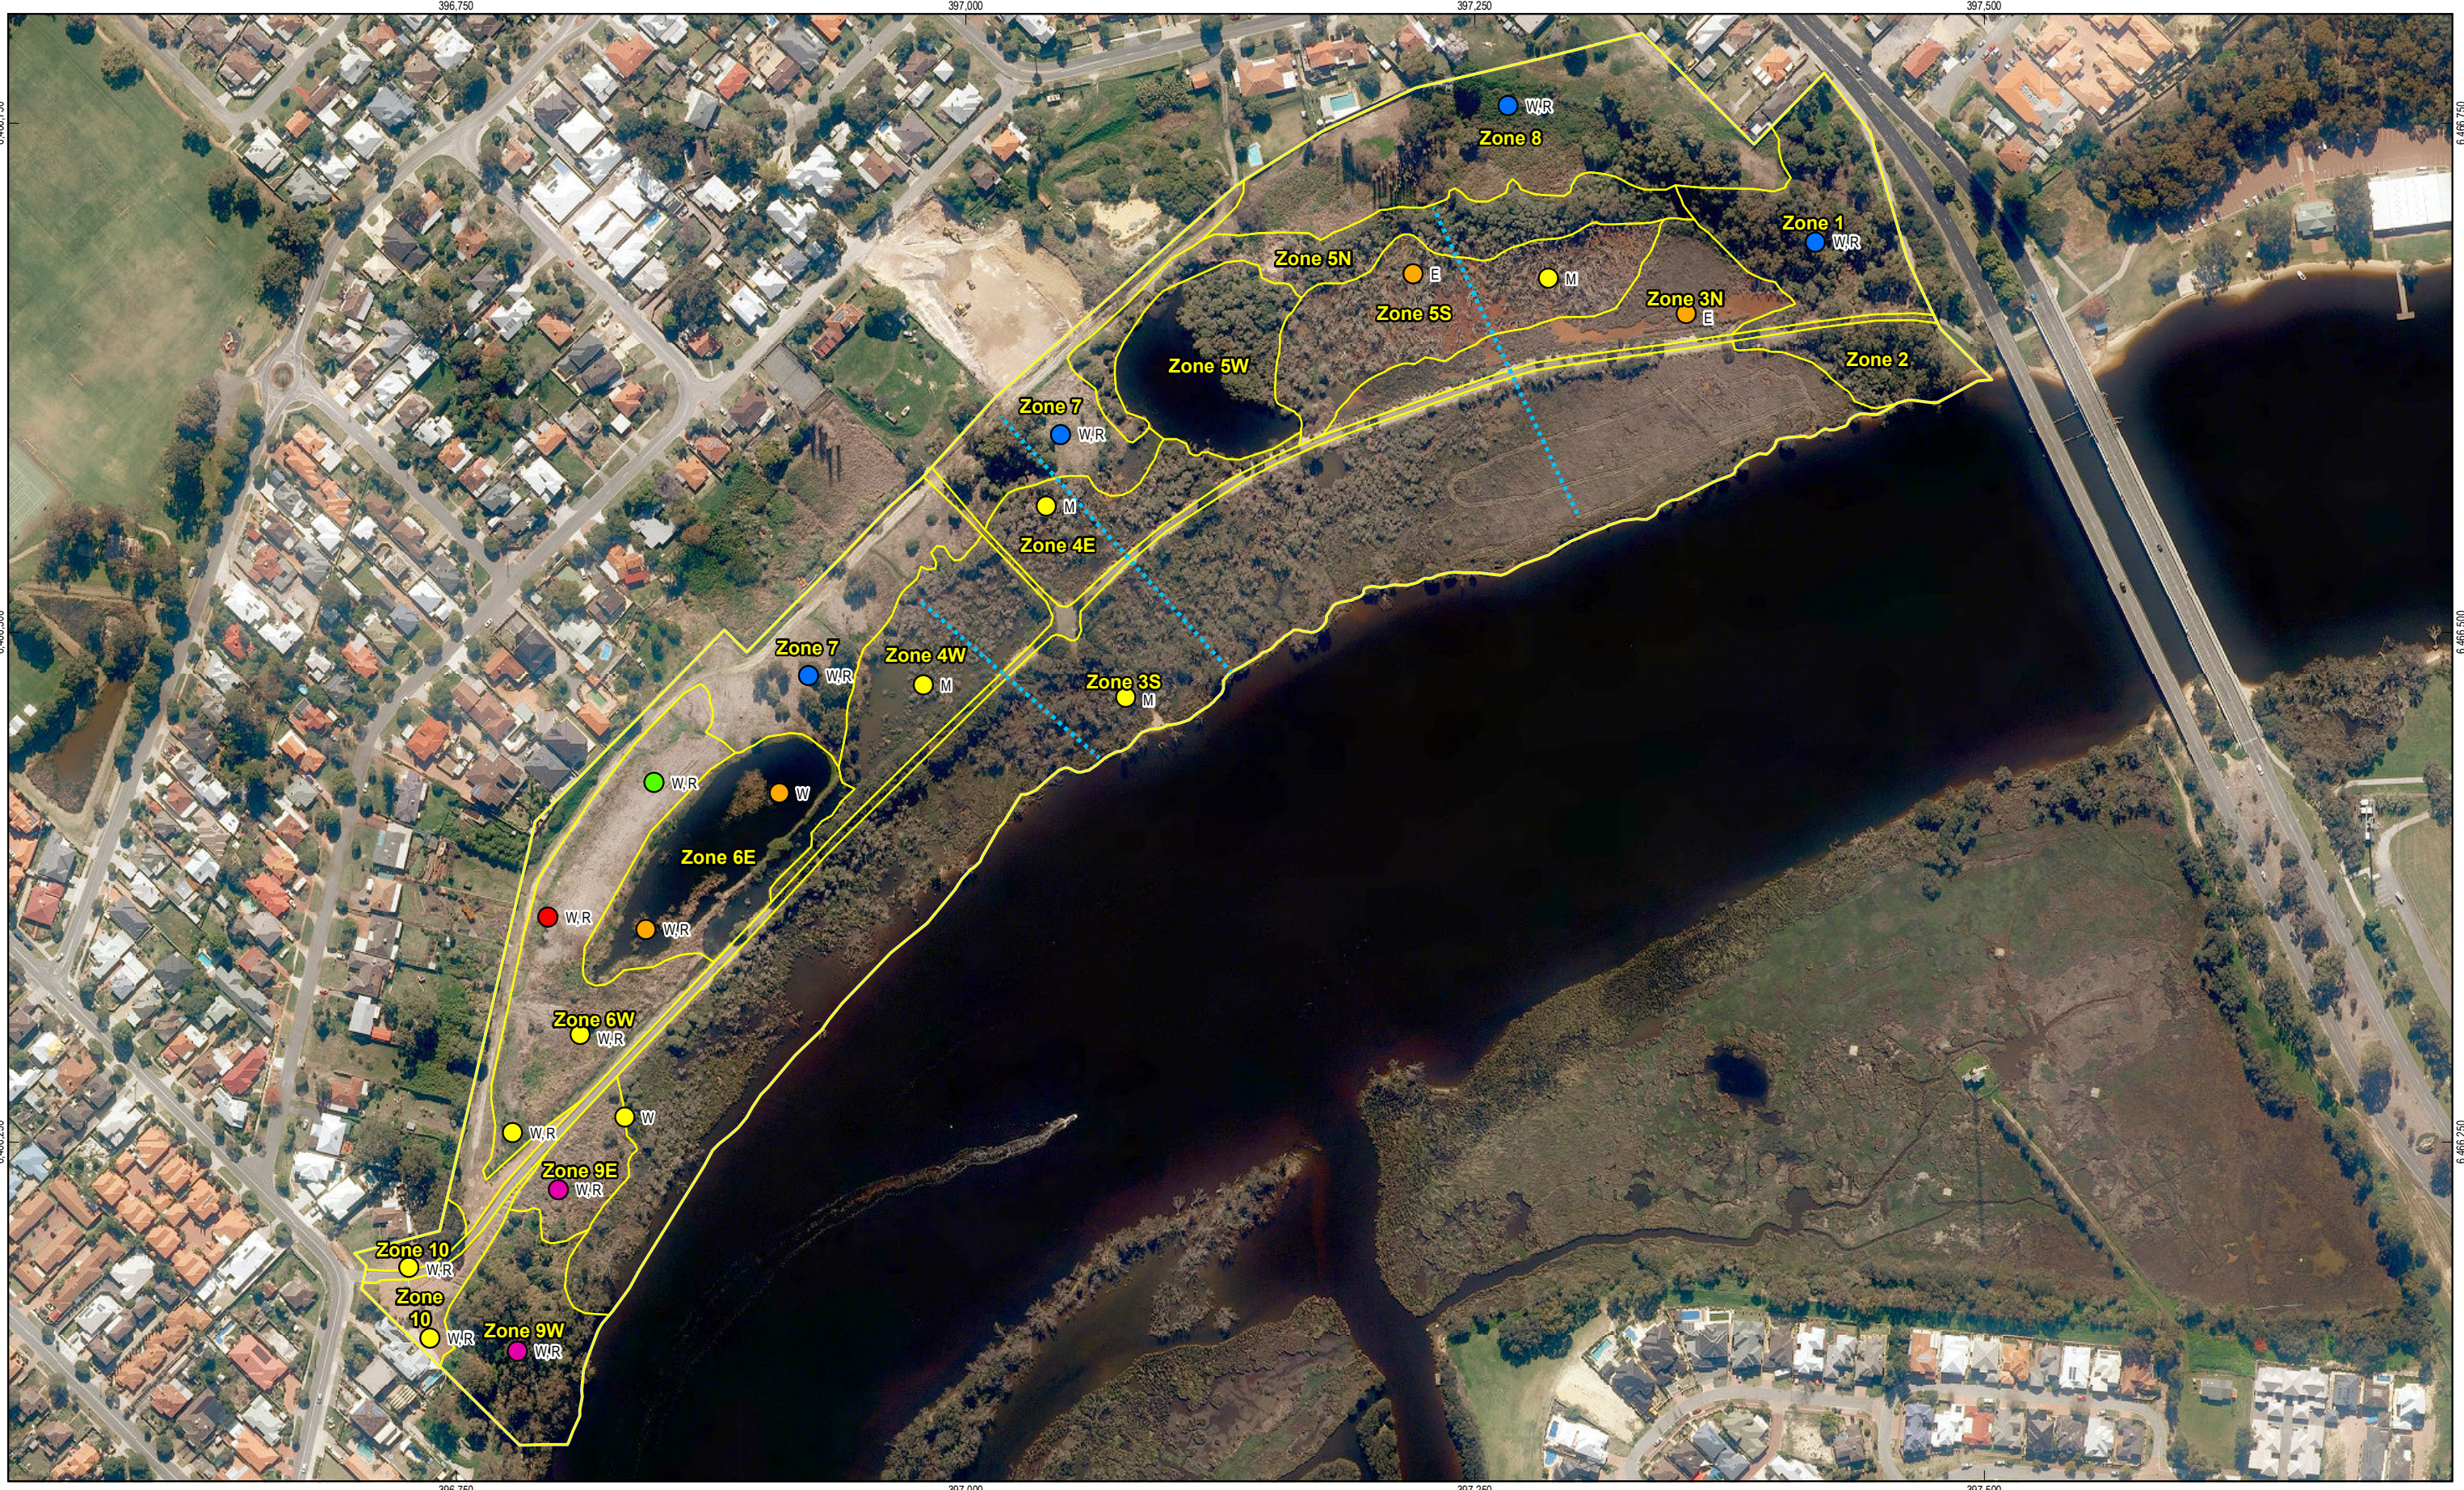
LEGEND		Timeframe		Work Locations:	
	Management Zones		Year 1		Years 2-3
	Study Area		Years 4-6		Years 1-2
	Proposed Monitoring Transect Locations		Years 1-3		Years 7-10
					WR - Revegetation
					W - Weed Control
					E - Engineering works
					M - Monitoring
