WHAT HAPPENS WHEN URBAN MEETS HIGH GROUNDWATER

SNAPSHOT - BRABHAM

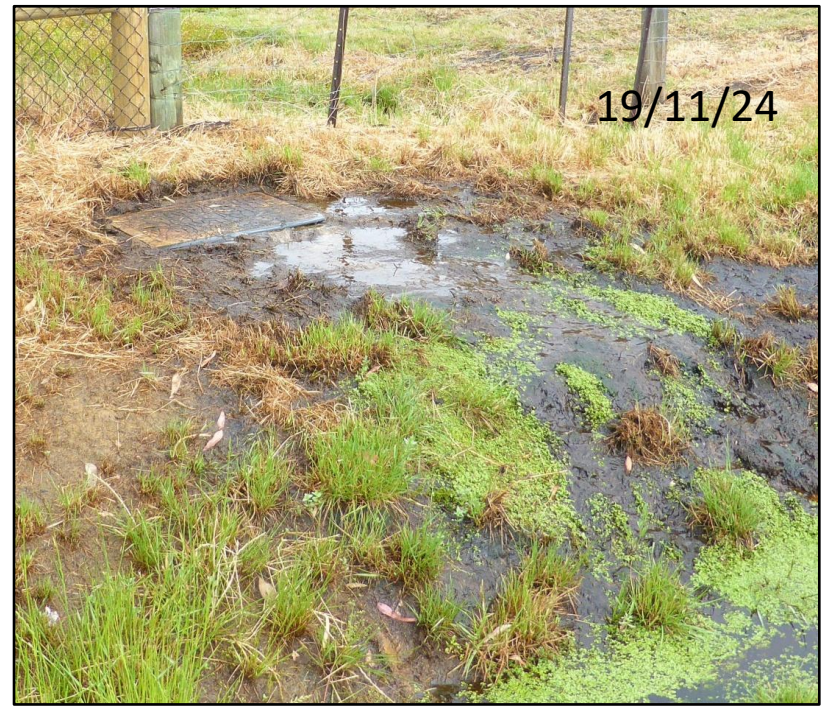
**Groundwater discharging from
Telecommunications Pit, Filip Way West Swan**

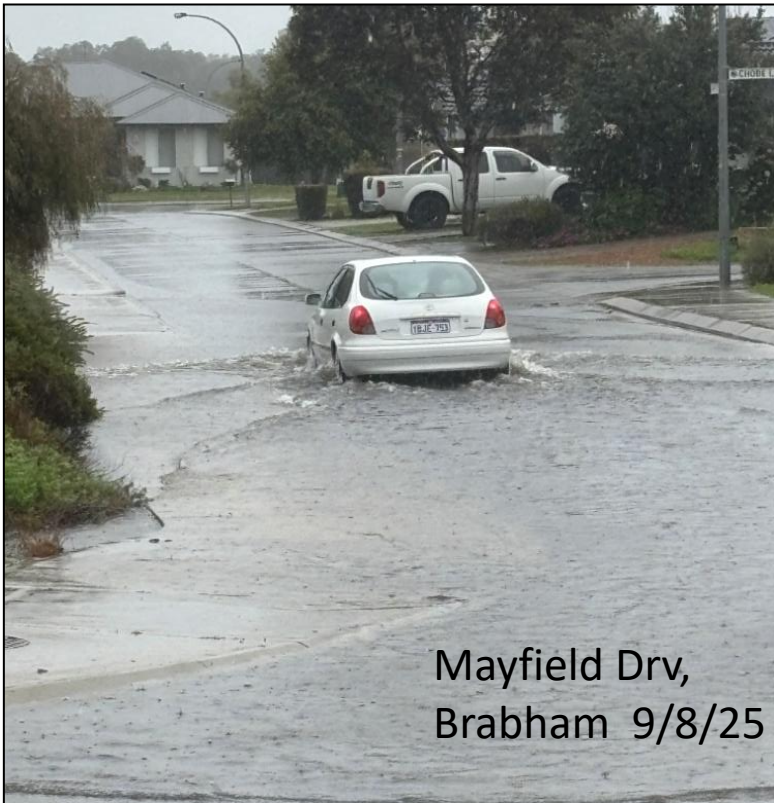
Mayfield Drv,
Brabham 9/8/25

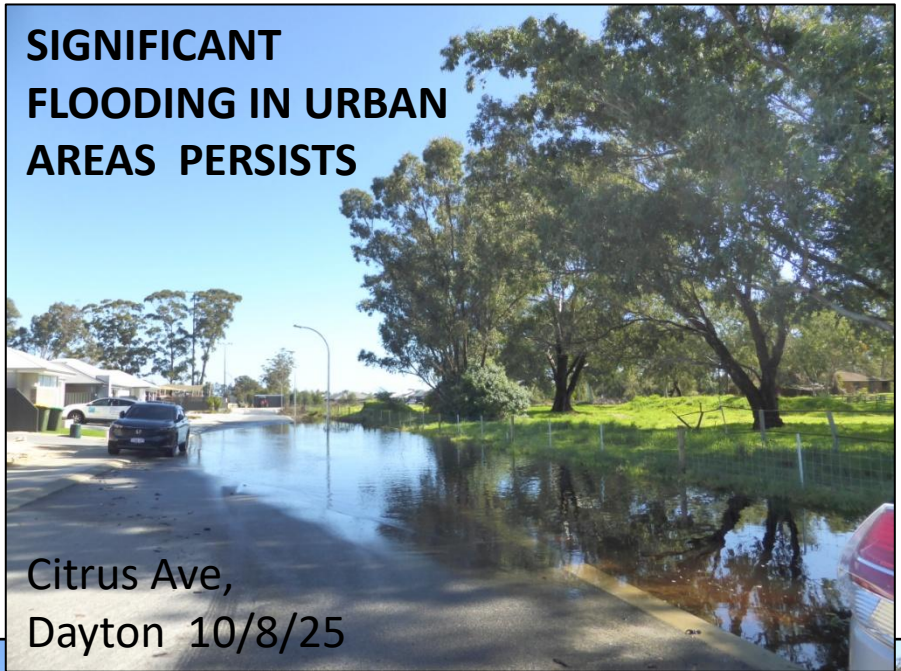
Citrus Ave,
Dayton 10/8/25

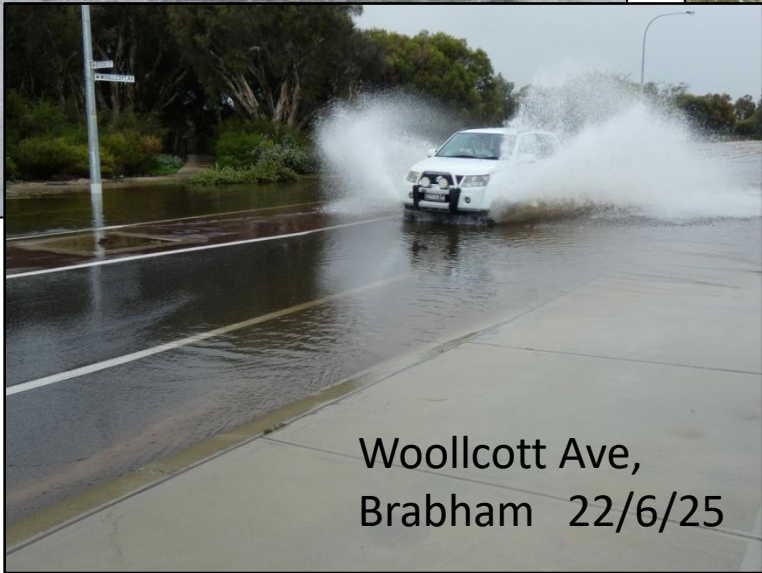
Woollcott Ave,
Brabham 22/6/25

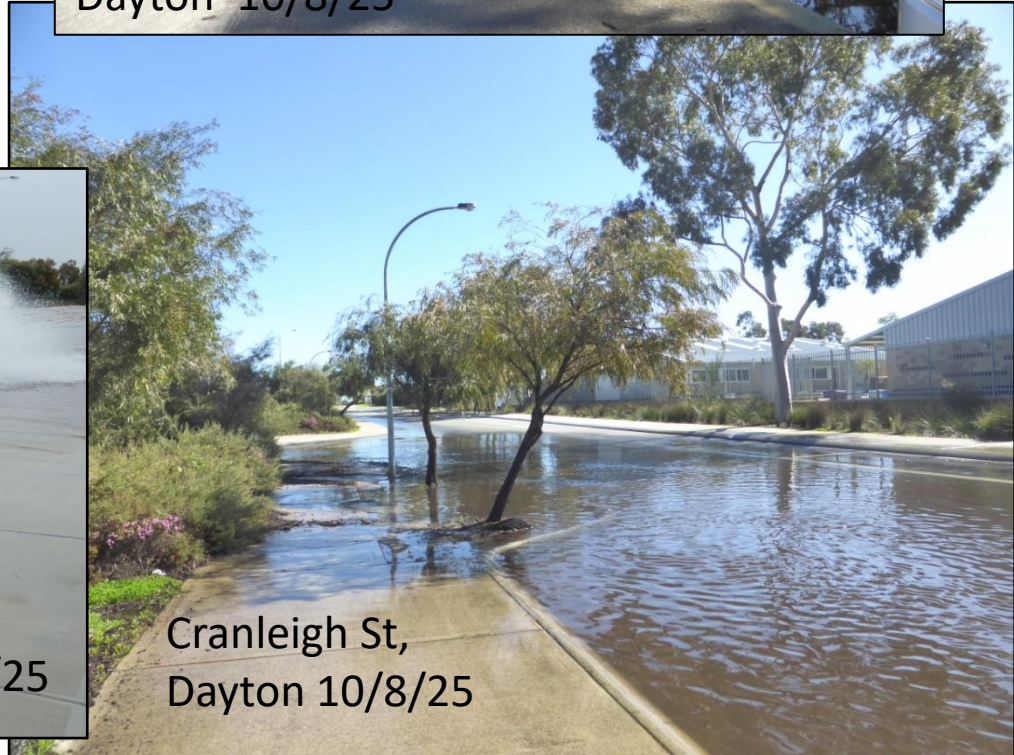
Cranleigh St,
Dayton 10/8/25

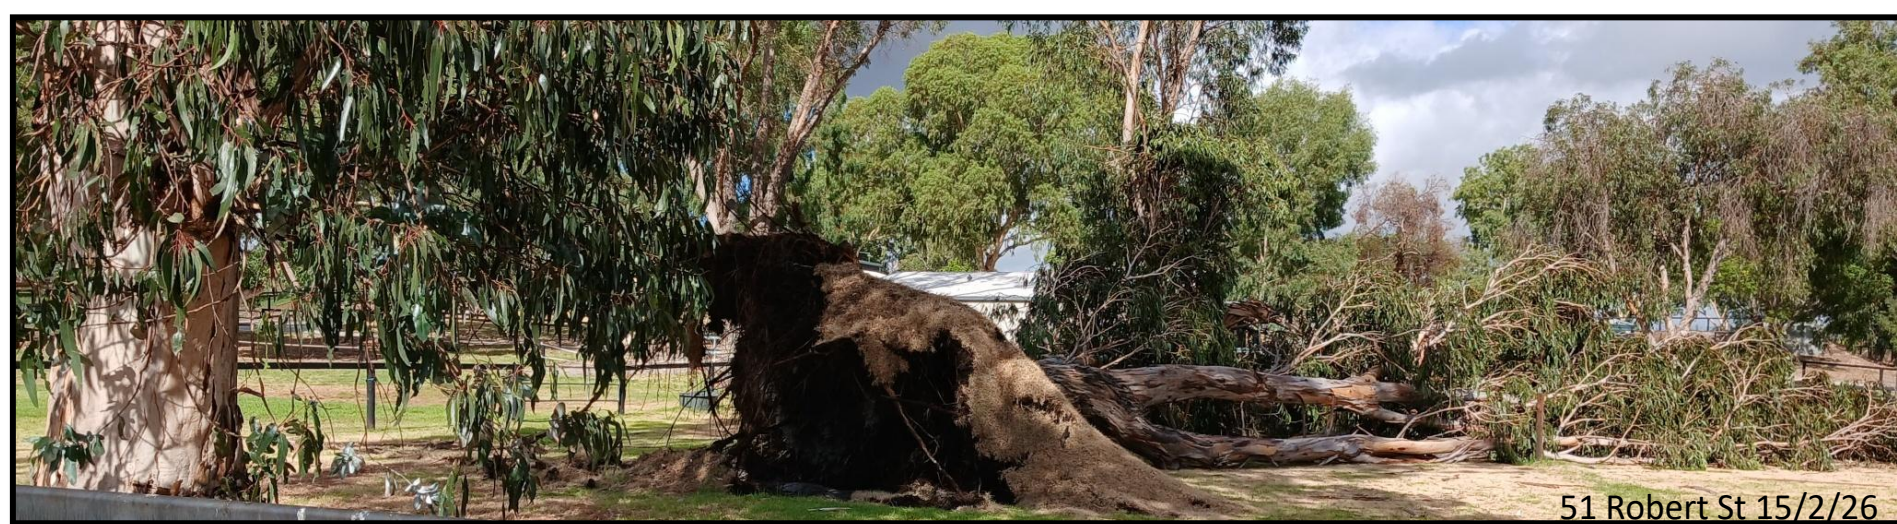
51 Robert St 15/2/26

Mature tree in rural property due east of new urban toppled Feb 2025. Ground was inundated from Sept 2025 till mid Feb 2026

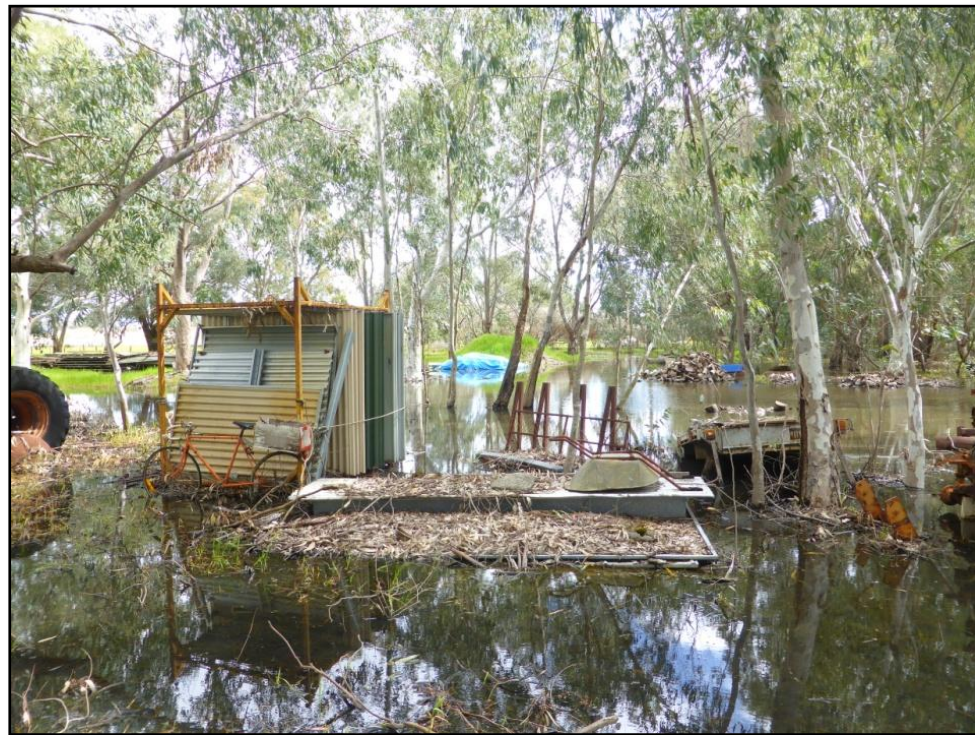
Flooding in rural Henley Brook due east of new urban
Sept 2025

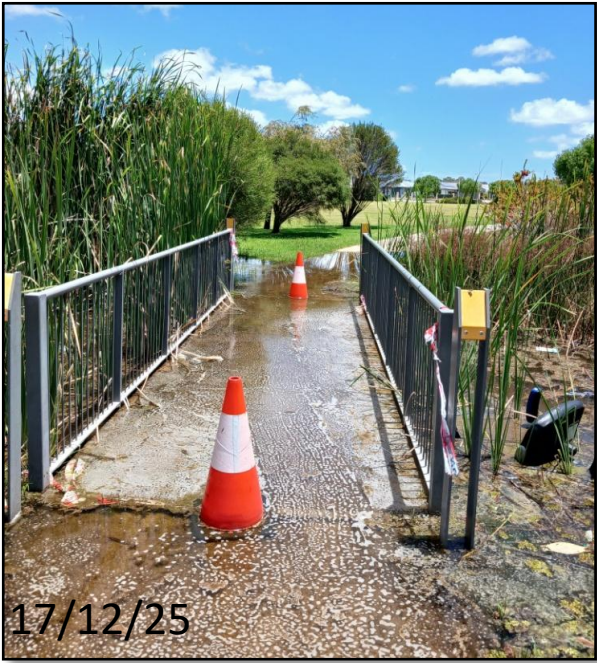
Whiteman Edge drainage infrastructure west of Mayfield Drive, Brabham

Reports indicate that there have been incidences of flooding along this drainage infrastructure for the last six years. The main drain extends from Heisler Park in the north to Blackmore Loop Park in the south. All, except one short section, was completely inundated and discharging through a road grate until late December 2025.

Water quality is exceptionally poor.

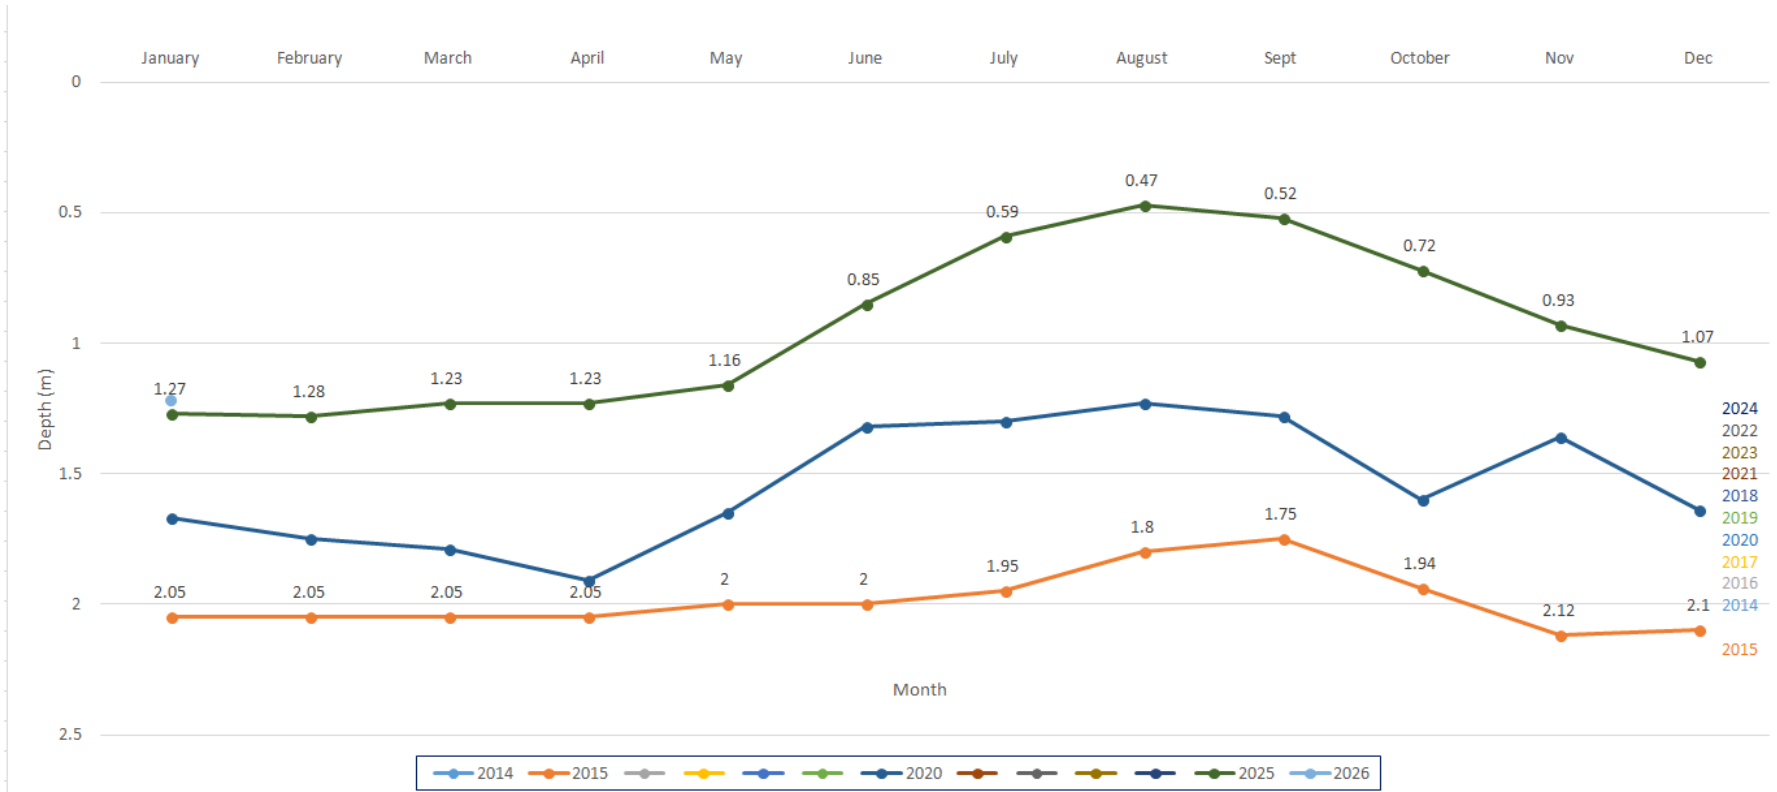
Bore 4

Groundwater levels Tree Farm on eastern side of Malvern St, Dayton (due east of urban development)

Depth to Groundwater Station 4 Tree Farm
5 yearly readings

Readings taken monthly, on last day of each month. The higher the point is towards the top of the graph, the shorter the distance from ground surface to groundwater. August 2025 read 25/8/25.

Note upward trend over time.

numbers recorded in red dry at this depth. water level is lower.

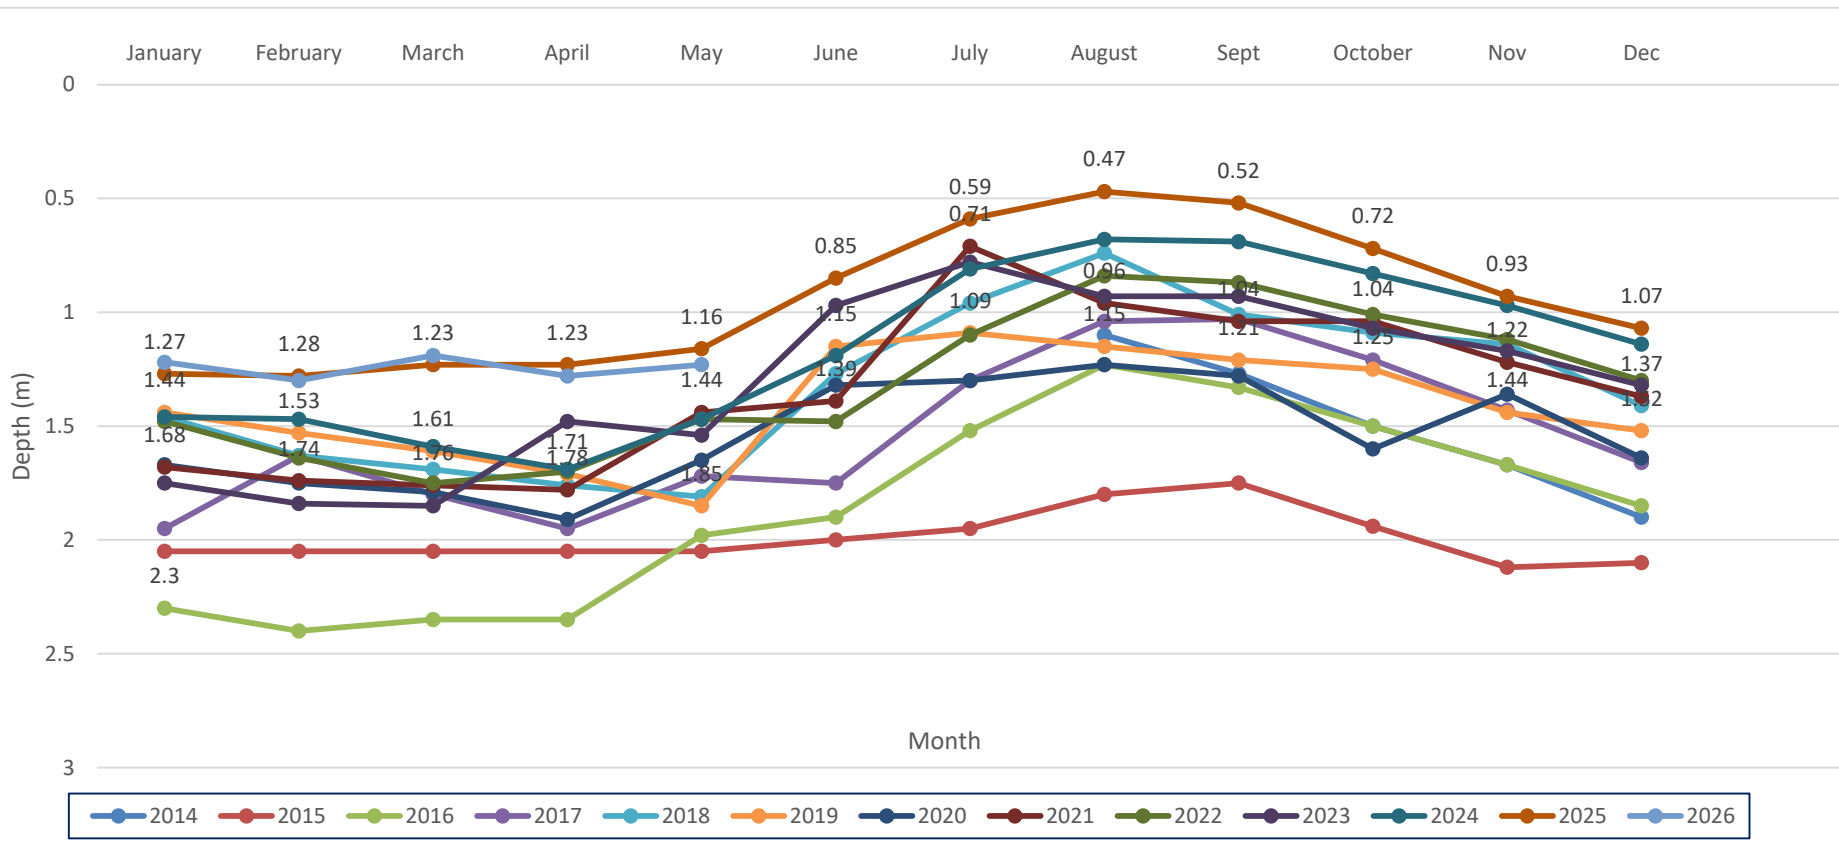
Groundwater levels Tree Farm on eastern side of Malvern St, Dayton (due east of urban development)

Depth to Groundwater Station 4 Tree Farm yearly readings

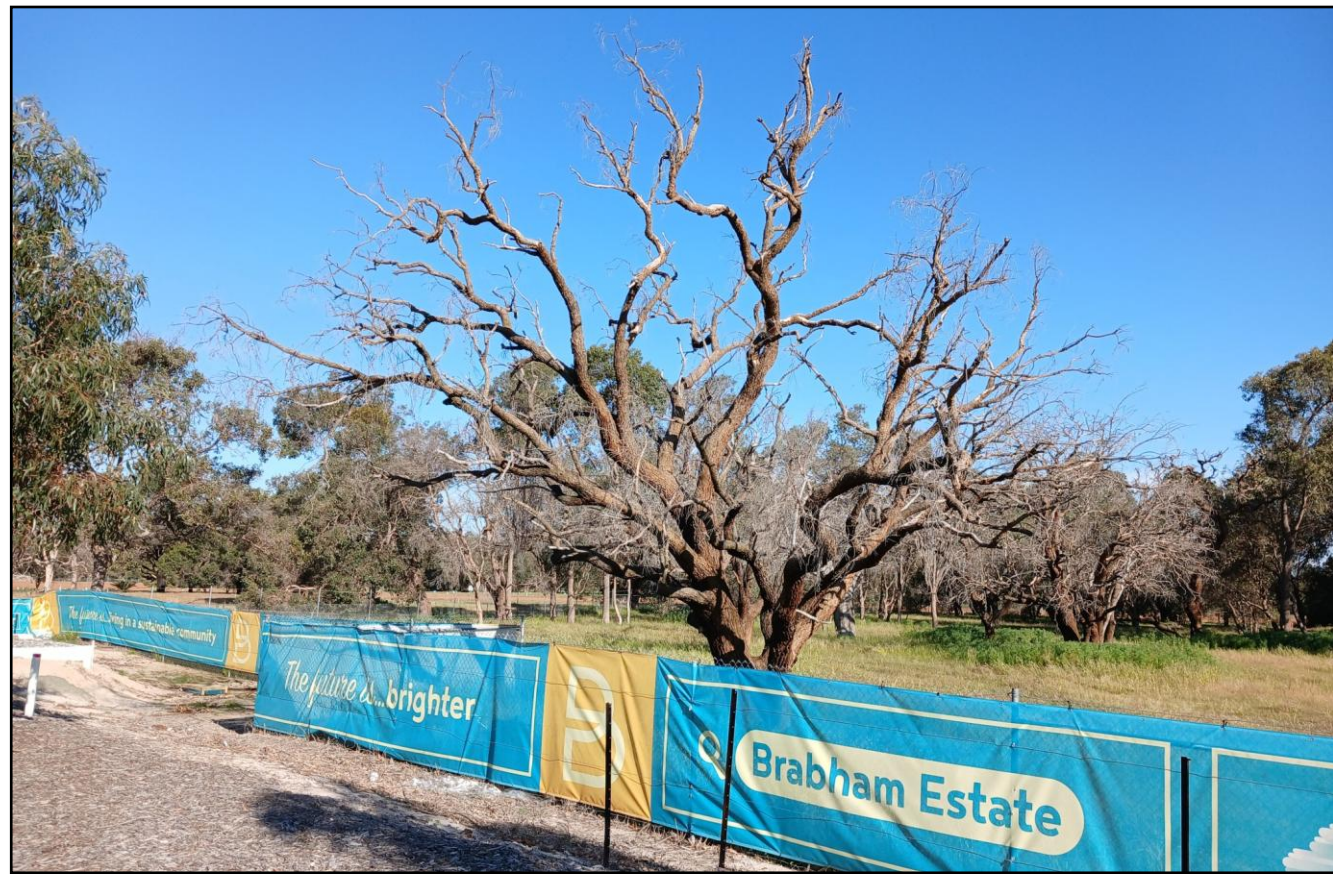
7 Prickley Barks (*Euc totdiana*) intended to be retained in POS 1, Brabham Stage 3, dead due to continuous inundation. Drainage from Brabham Stage 1 is piped under Youle-Deal Rd and discharged directly onto the ground (see below).

Brabham can't be called sustainable when the drainage doesn't work.

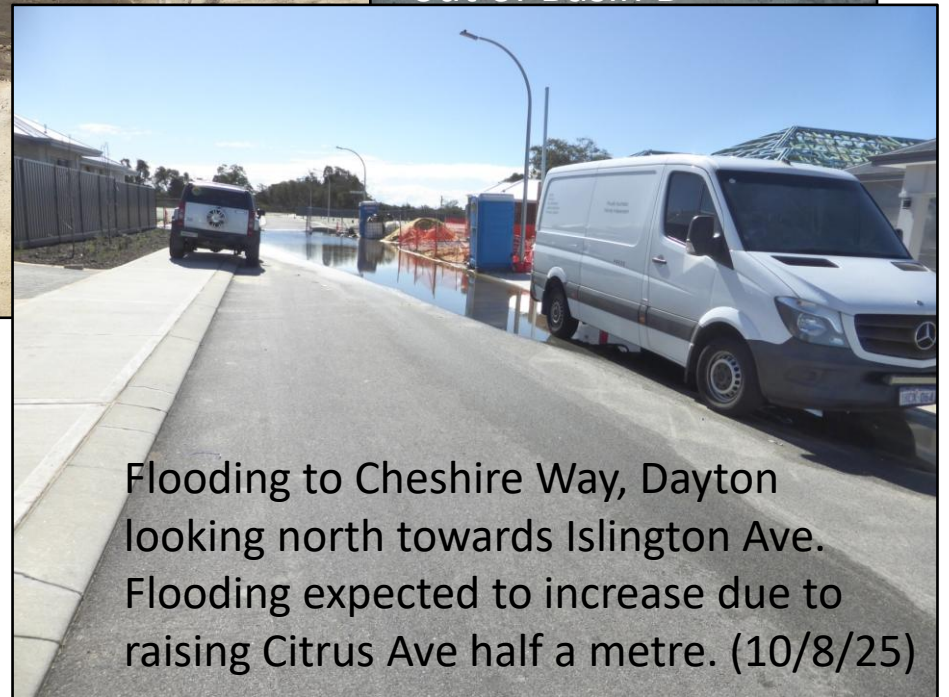
Flooding to Cheshire Way, Dayton looking north towards Islington Ave. Flooding expected to increase due to raising Citrus Ave half a metre. (10/8/25)

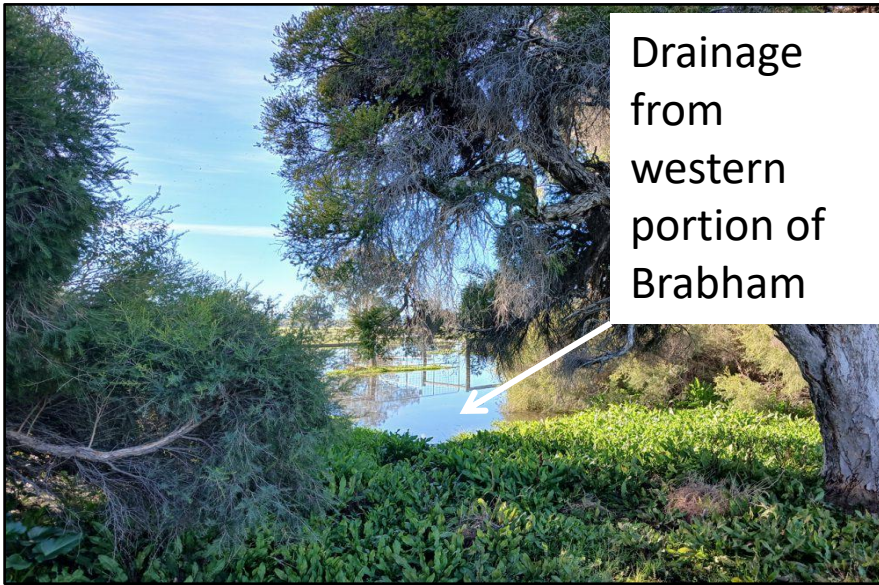
Drainage
from
western
portion of
Brabham

Horse Swamp: Photos taken
5/5/26 before rain

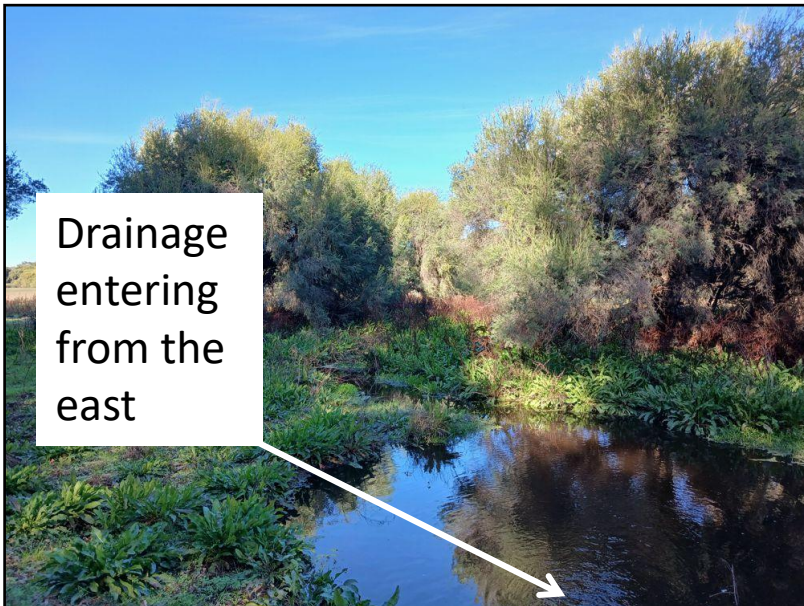
Drainage
entering
from the
east

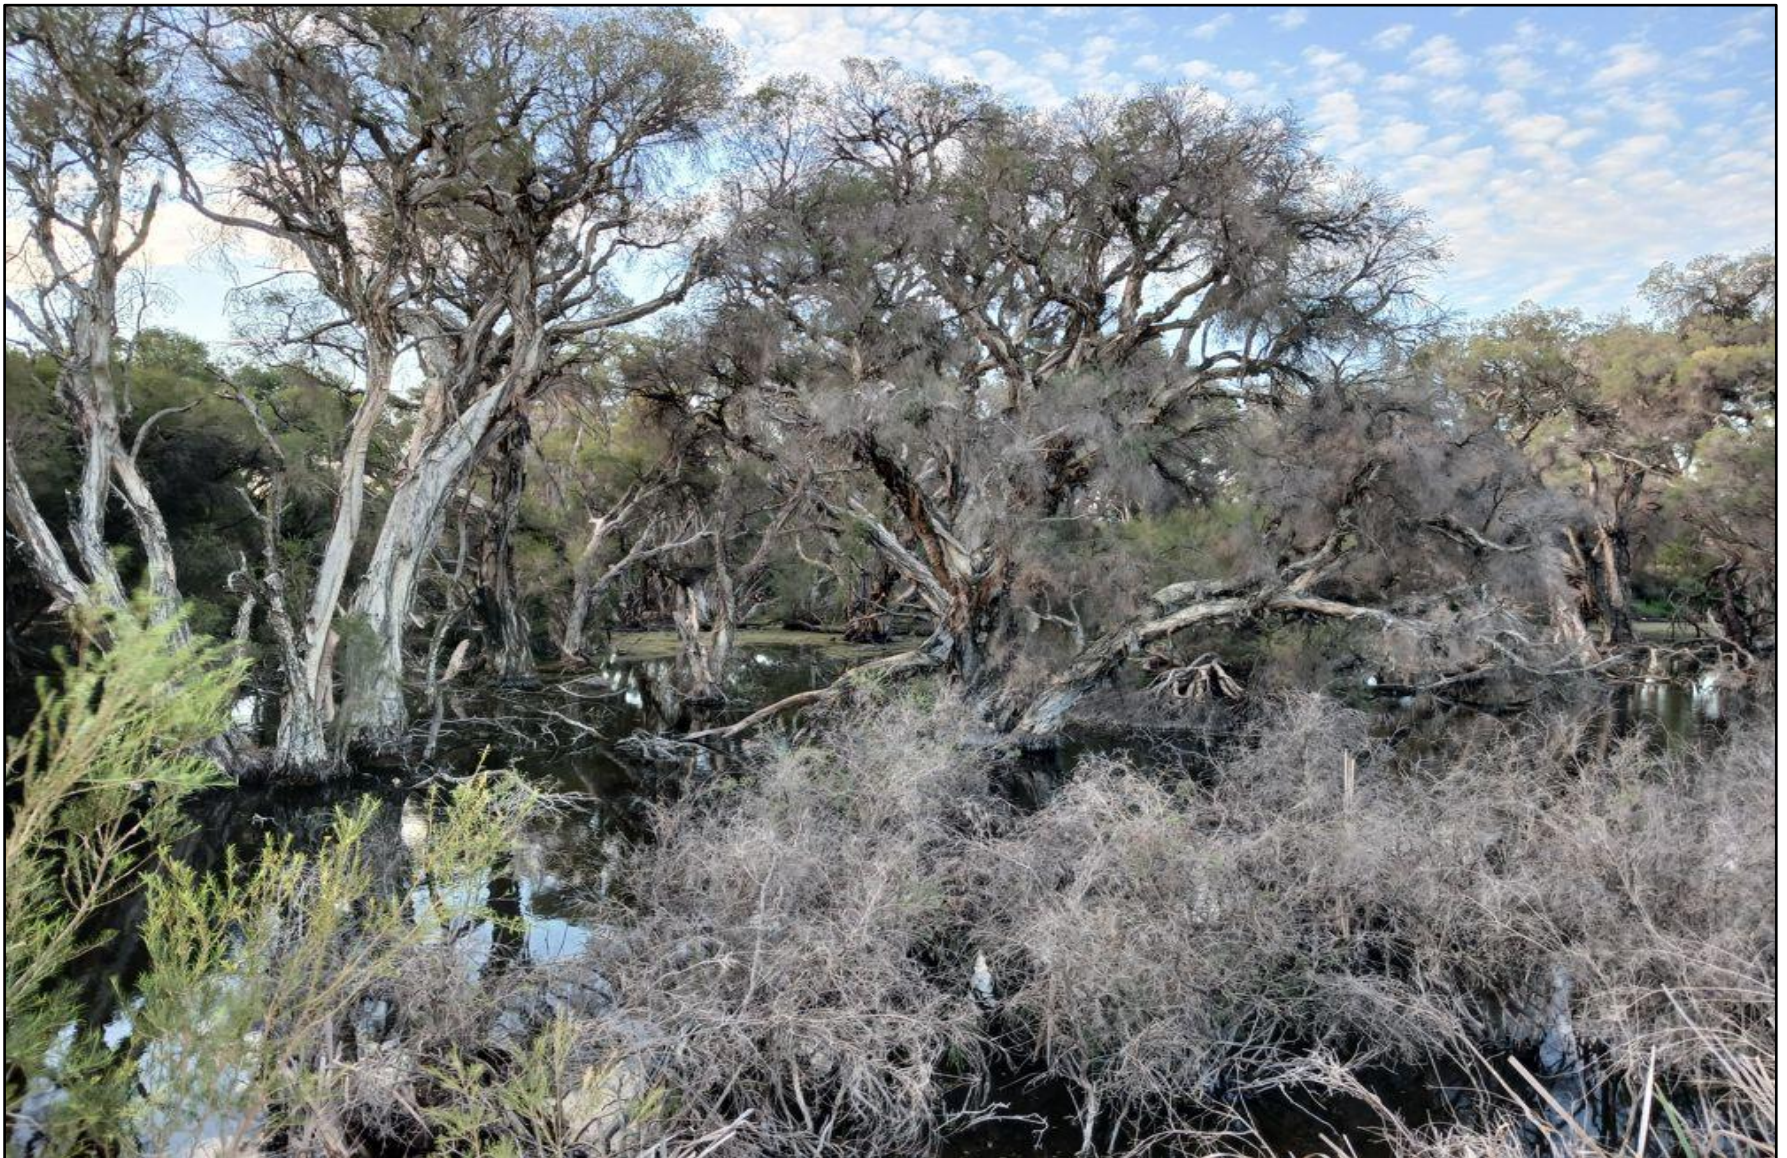
Watervalley Boulevard, Woollcott Ave, Brabham : A Resource Enhancement Wetland that was supposed to be rehabilitated. The wetland has been used dammed and as a flood storage area. After 15 years it is slowly collapsing. Trees are dying, algal blooms are becoming more prolific, odour levels are rising and mosquitoes breeding.
